**Climate Proofing Housing Landscapes:  
Monitoring Report 2**

**June 2016 to September 2016**

**Authors: Connop, S., Clough, J., Gunawardena, D. and Nash, C.**

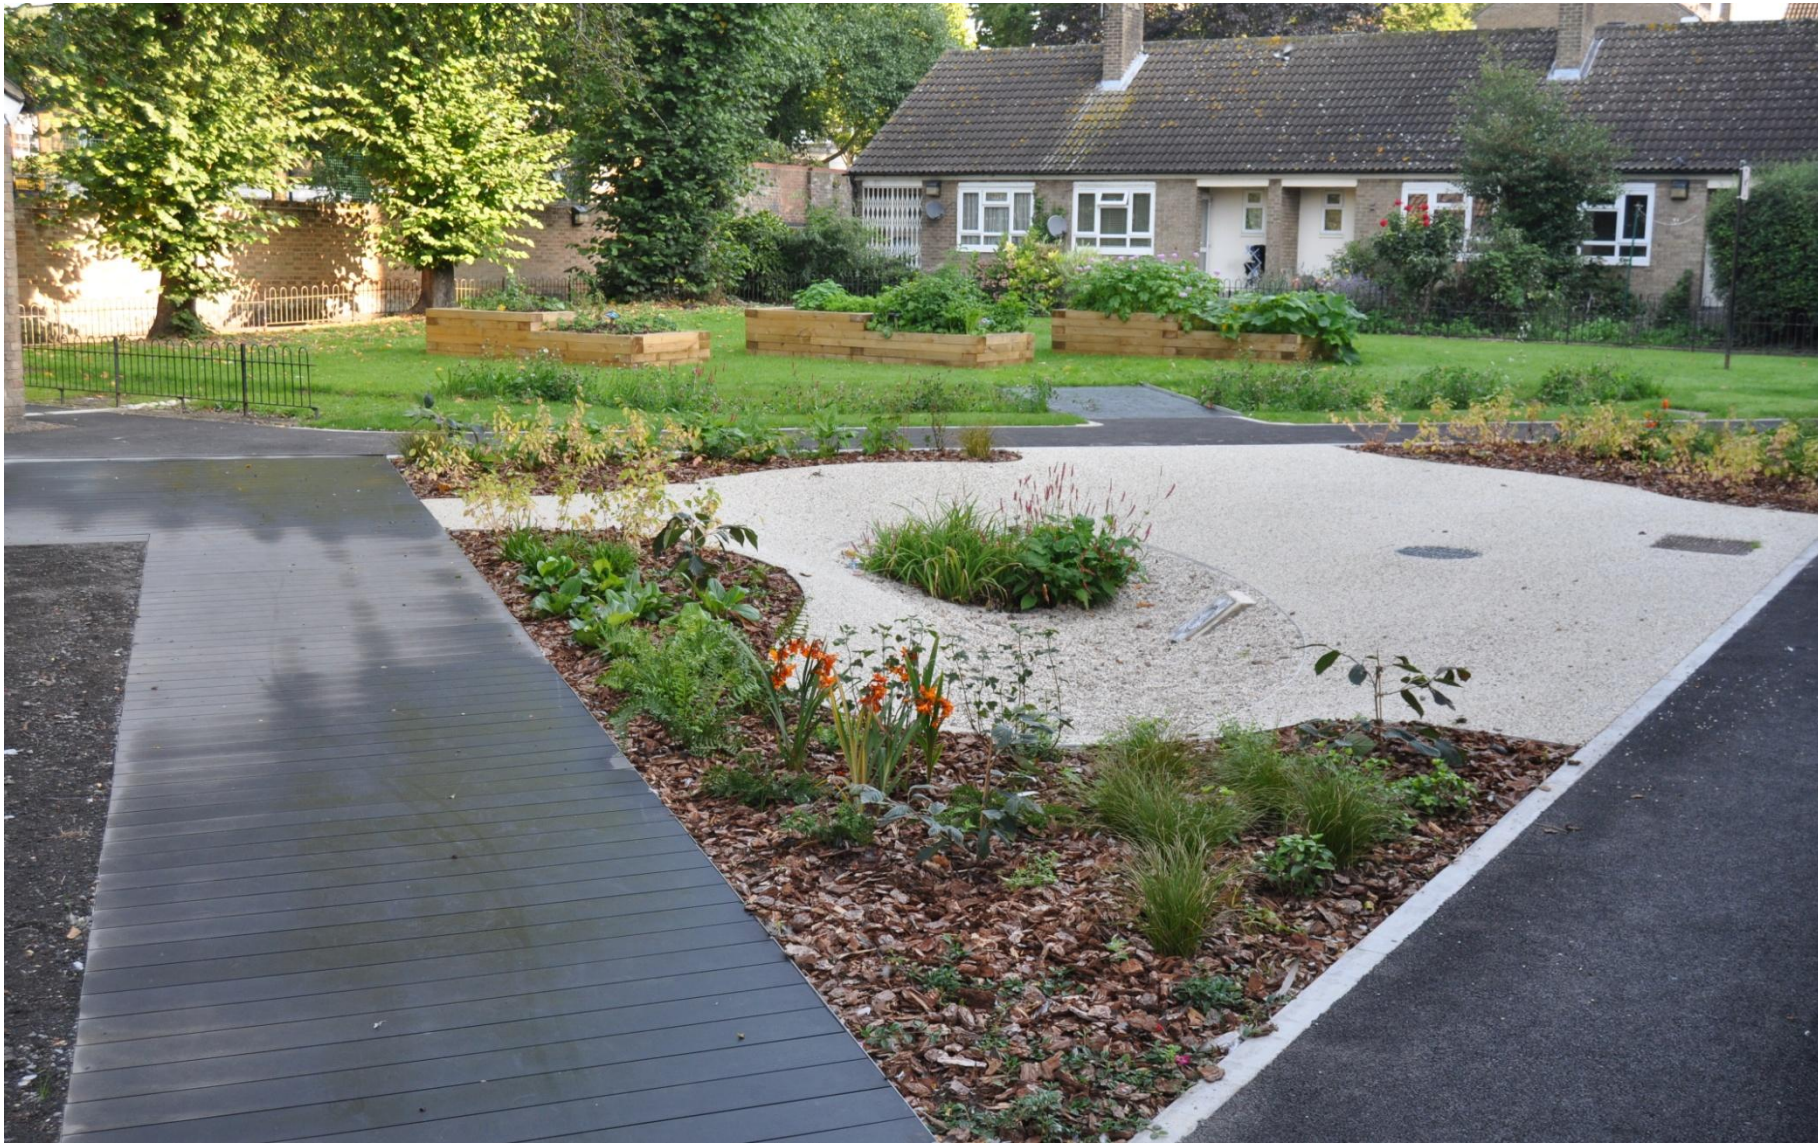
**Figure 1. Green infrastructure retrofit at Queen Caroline Estate, London Borough of Hammersmith & Fulham.** Raised planters, permeable pathways, ornamental planting, pollinator-friendly swales and detention basins.

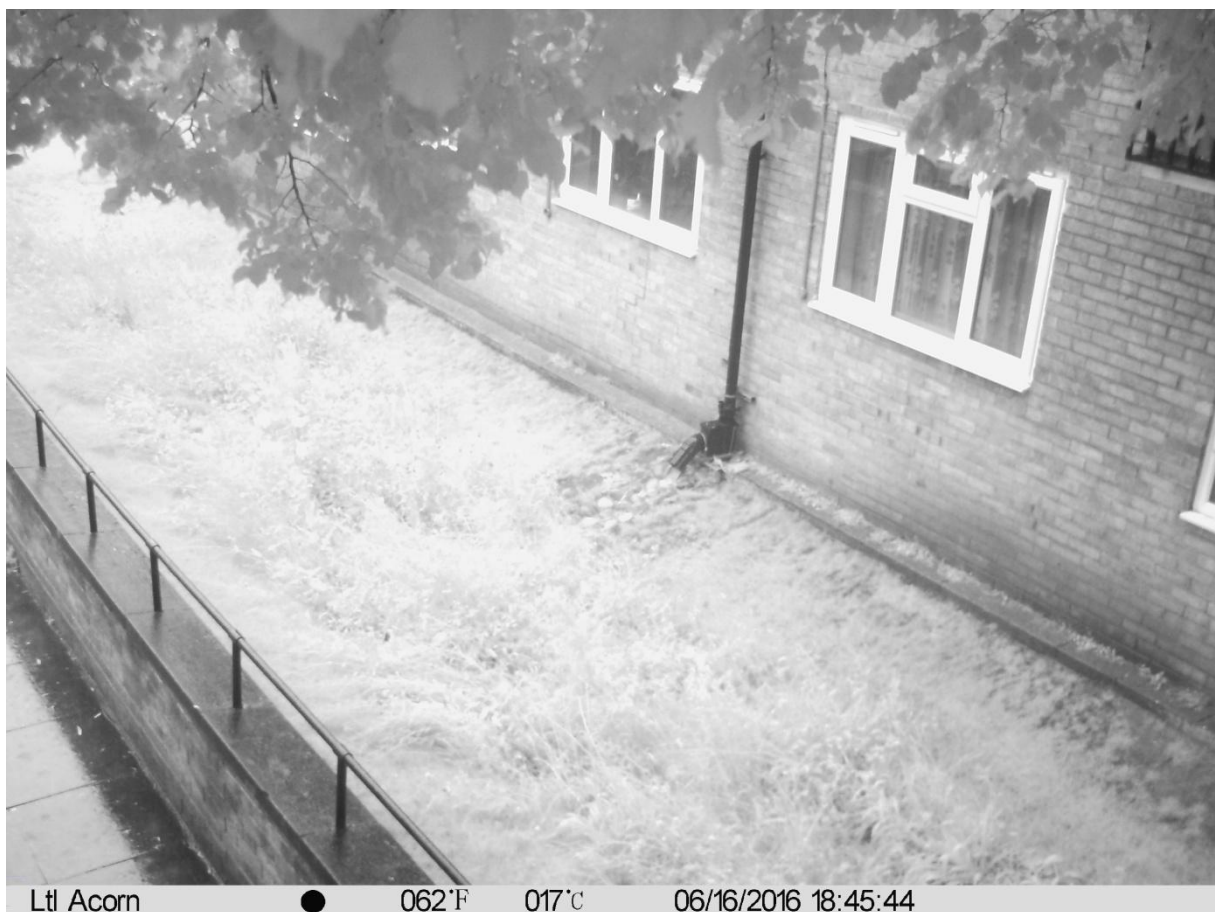
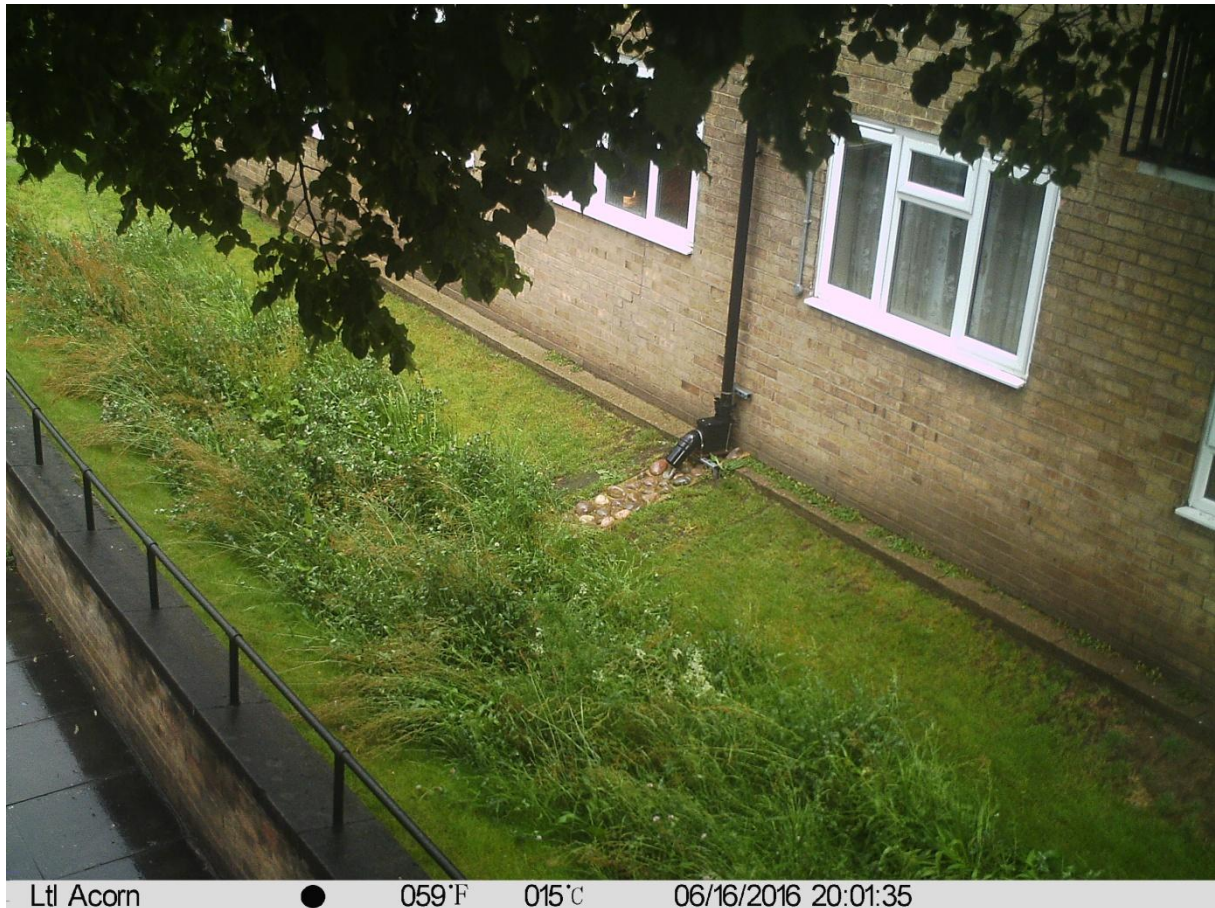
**Figure 8. Time-lapse camera images from Beatrice House swale (FPC4).** Images show i) evidence of swale filling during period of highest rain intensity at 18:45 on 16/06/2016 [32.8 mm of rain at maximum intensity of 188.8 mm/hr] and ii) evidence of infiltration/conveyance by the end of the intense rain event at 20:00 on the same day.

A complete collection of the images from the Beatrice swale during the heaviest rain event recorded since the monitoring equipment was installed (from 18:30 to 20:00 on the 12th June 2016) are presented in Appendix A. They demonstrate that the swale was able to retain and attenuate all of the rainfall that fell directly onto the area and that which was diverted from the roofs of Beatrice House. The images also demonstrate that at around 18:45 during the peak of the rainfall, despite substantial input from the downpipe, there was no obvious standing water within the swale (Figure 8.i). The light conditions immediately after this time make it difficult to see whether pooling occurred after this (low light levels causing a switch between day vision and night vision - see Appendix A), but by the time of the next clear images at 20:00, at the end of the intense rain event, there was no obvious pooled water (Figure 8. ii) indicating that the swale was releasing the stormwater by infiltration and/or conveyance.

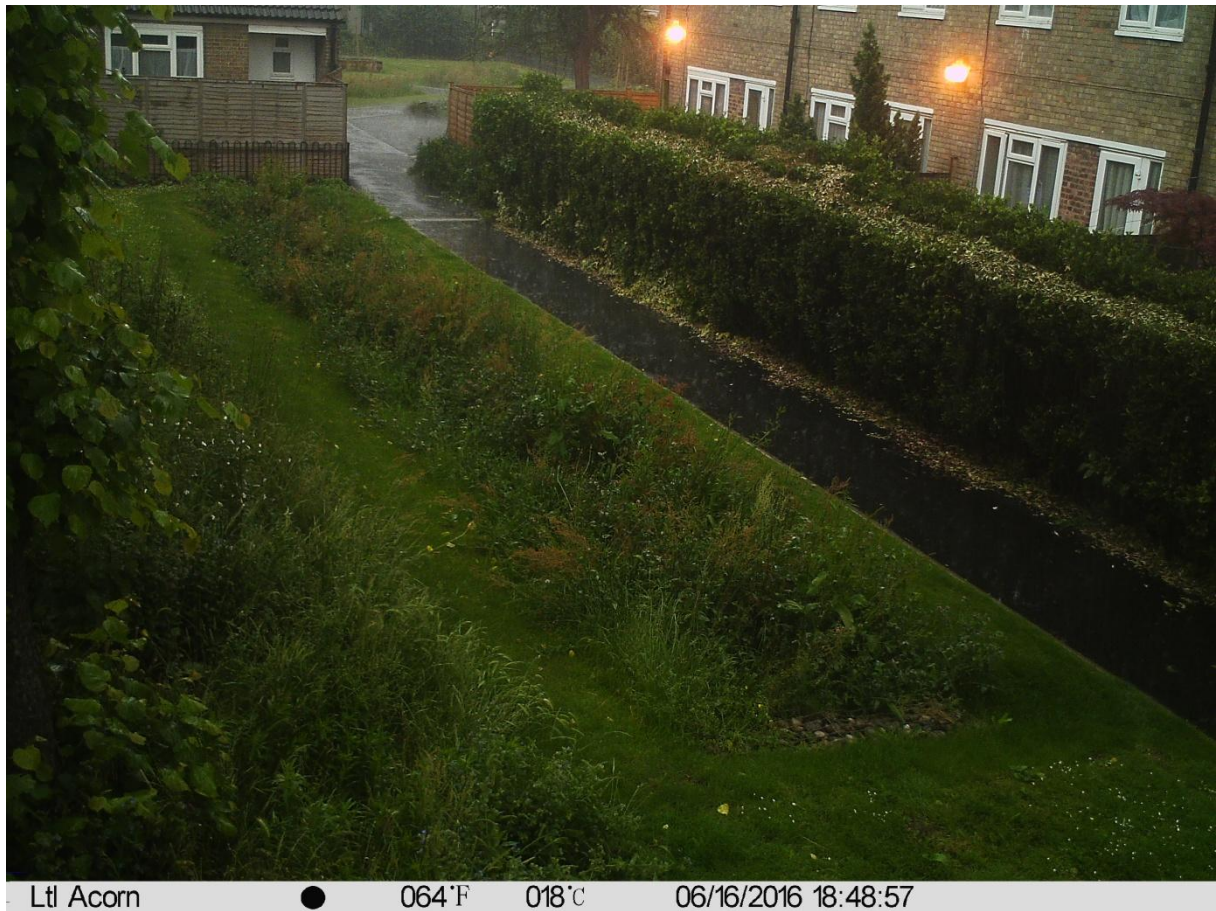
**Figure 9. Time-lapse camera images from Alexandra House swale (FPC1).** Image shows no evidence of swale filling excessively during period of highest rain intensity 18:30 to 20:00 on 16/06/2016 [32.8 mm of rain at maximum intensity of 188.8 mm/hr].

Images showing the performance of the Alexander House swale for the same rain event are presented in Appendix A2. The swale was designed to take stormwater from the surrounding ground level permeable and hardstanding areas and from the roof of the neighbouring Alexandra House. Whilst the fixed point photos showed evidence of the intensity of the rain event in relation to pooling on the ground, there was no evidence of any substantial filling or overflowing of the swale. This was the case even during the most intense period of rainfall (Figure 9). This indicated that the swale was performing as expected for this rain event. It is important to note at this point, however, that lack of maintenance of the guttering on Alexandra House might mean that not all of the rain falling on the areas of the roof that should be diverted to the swale is actually reaching the swale.

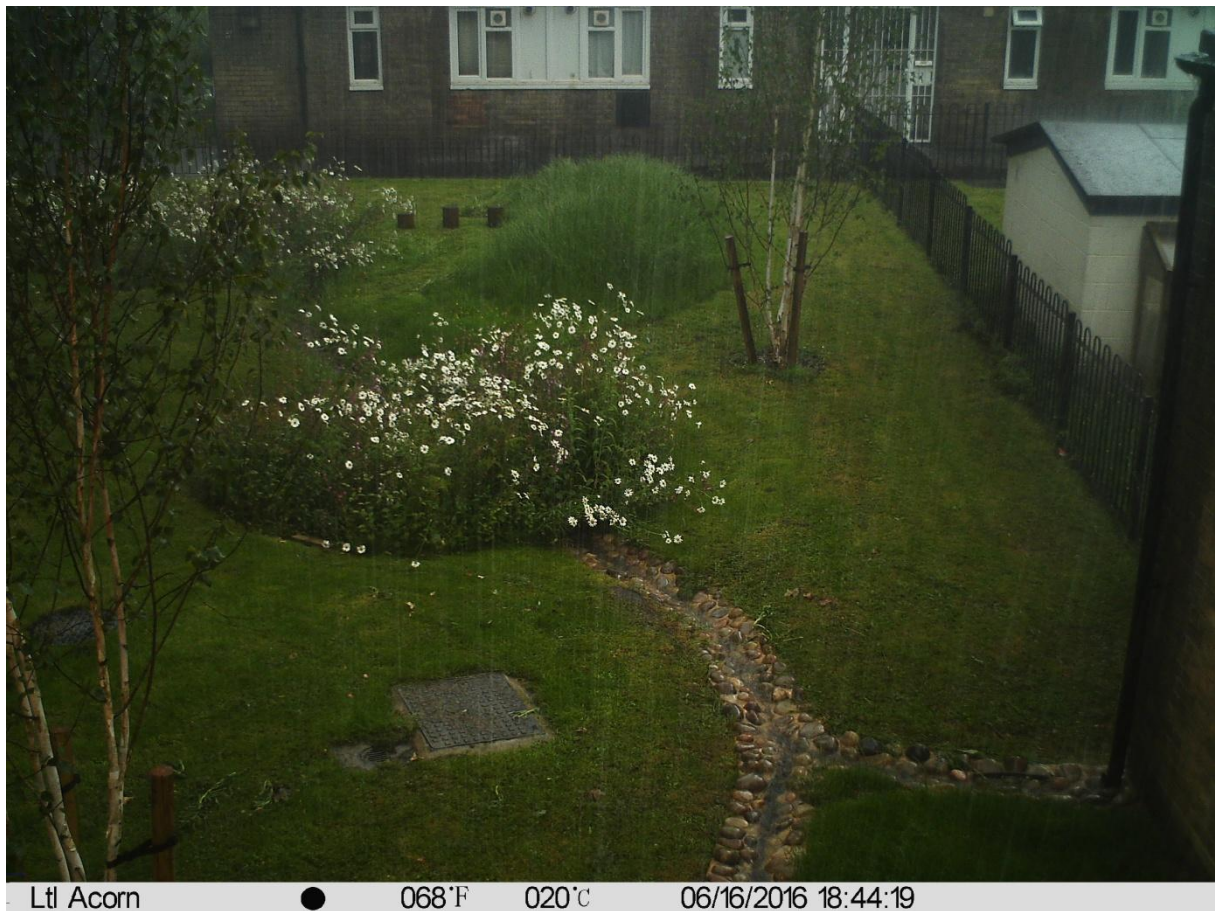
**Figure 10. Time-lapse camera images from Community Hall and Sophia House basins (FPC2).** Image shows no evidence of swale filling excessively during period of highest rain intensity 18:30 to 20:00 on 16/06/2016 [32.8 mm of rain at maximum intensity of 188.8 mm/hr].

Images showing the performance of the Community Hall and Sofia House grass basins for the same rain event are presented in Appendix A3. The basins were designed to take stormwater from the surrounding ground level permeable and hardstanding areas and from the roof of the neighbouring Community Hall and Sophia House. Whilst the fixed point photos showed evidence of the intensity of the rain event in relation to pooling on the ground, there was no evidence of any substantial filling of the basins. This was the case even during the most intense period of rainfall (Figure 10). This indicated that the basins were performing as expected for this rain event.

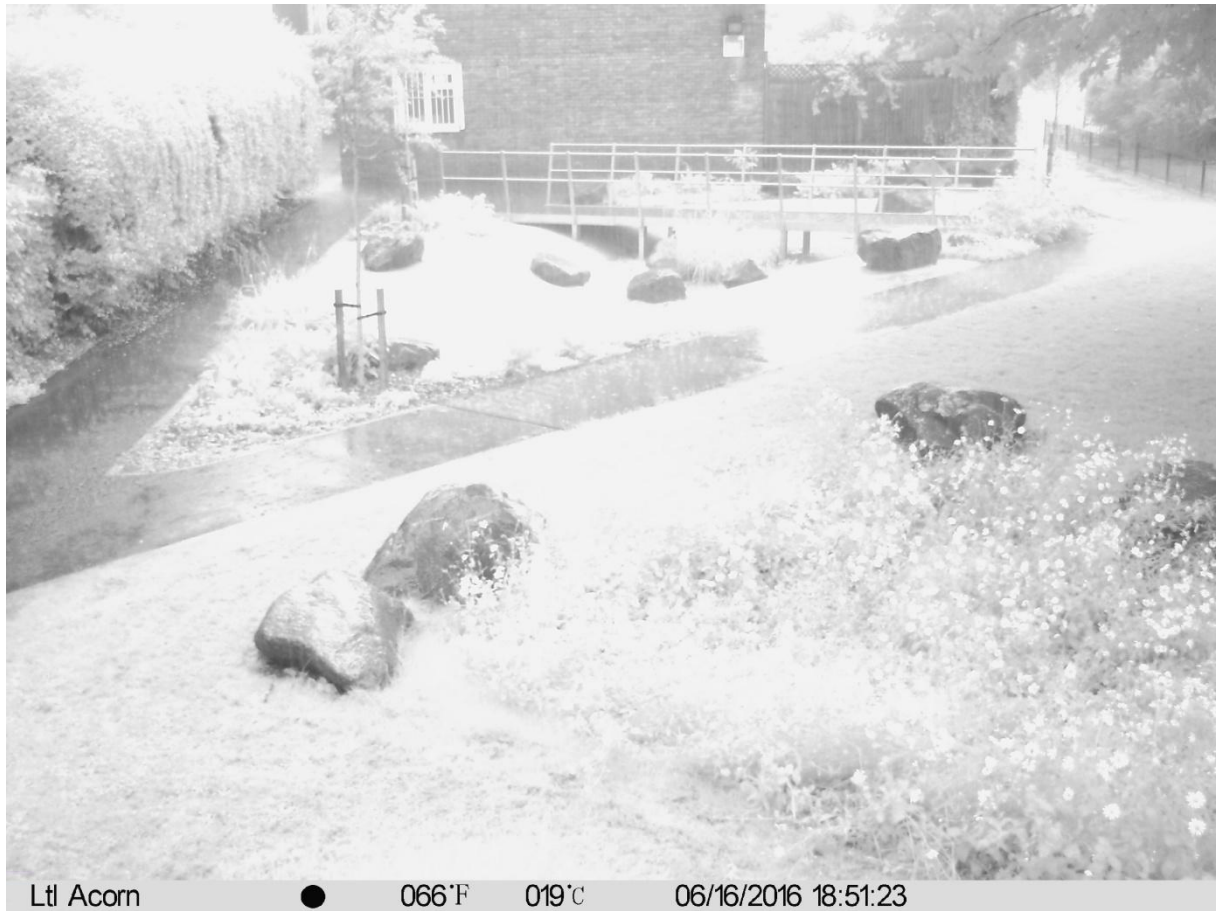
**Figure 11. Time-lapse camera images from Adella House grass basin and Adella House stoney basin (FPC3).** Image shows no evidence of swale filling excessively during period of highest rain intensity 18:30 to 20:00 on 16/06/2016 [32.8 mm of rain at maximum intensity of 188.8 mm/hr].

Images showing the performance of the Adella House grass basin and Adella House stoney basin for the same rain event are presented in Appendix A4. The basins were designed to take stormwater from the surrounding ground level permeable and hardstanding areas and from the roof of Adella House. Whilst the fixed point photos showed evidence of the intensity of the rain event in relation to pooling on the ground, there was no evidence of any substantial filling of the basins. This was the case even during the most intense period of rainfall (Figure 11). This indicated that the basins were performing as expected for this rain event. It is important to note at this point, however, that lack of maintenance of the guttering on Adella House might mean that not all of the rain falling on the areas of the roof that should be diverted to the basins is actually reaching the basins.

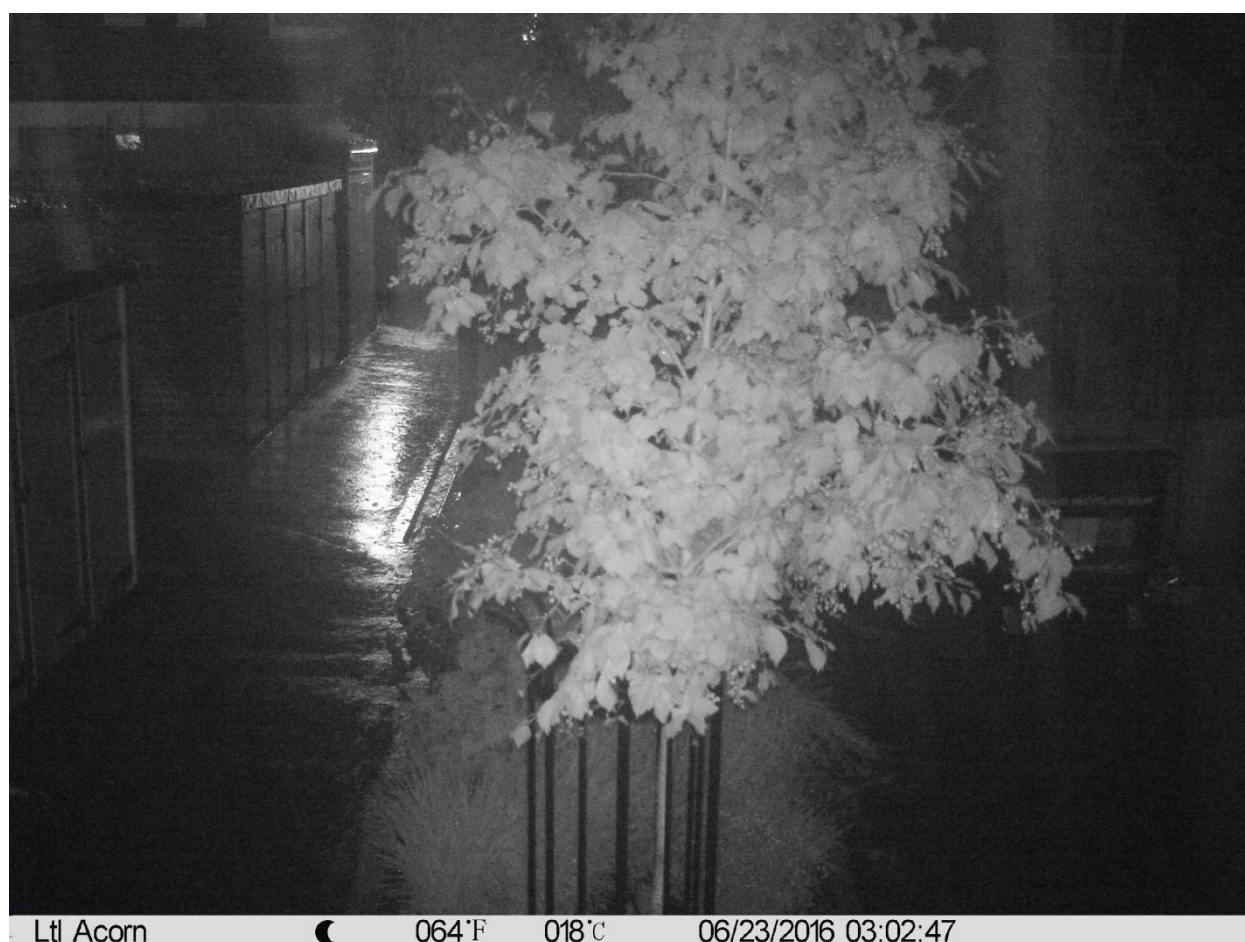
**Figure 13. Time-lapse camera images from Richard Knight House rain garden (FPC5).** Image shows no evidence of rain garden filling excessively during period of highest rain intensity 01:00 and 04:00 on 23/06/2016 [17.2 mm of rain at maximum intensity of 91.4 mm/hr].

Images showing the performance of the Richard Knight House rain garden for the rain event on 23rd June 2016 are presented in Appendix A5. The basins were designed to take stormwater from the ground level permeable and hardstanding areas surrounding the rain garden, from the green roofs on the pram sheds and from the roof of a neighbouring house. Whilst the fixed point photos showed evidence of the intensity of the rain event in relation to pooling on the ground, there was no evidence of any substantial filling of the basins. This was the case even during the most intense period of rainfall (Figure 13). This indicated that the basins were performing as expected for this rain event.

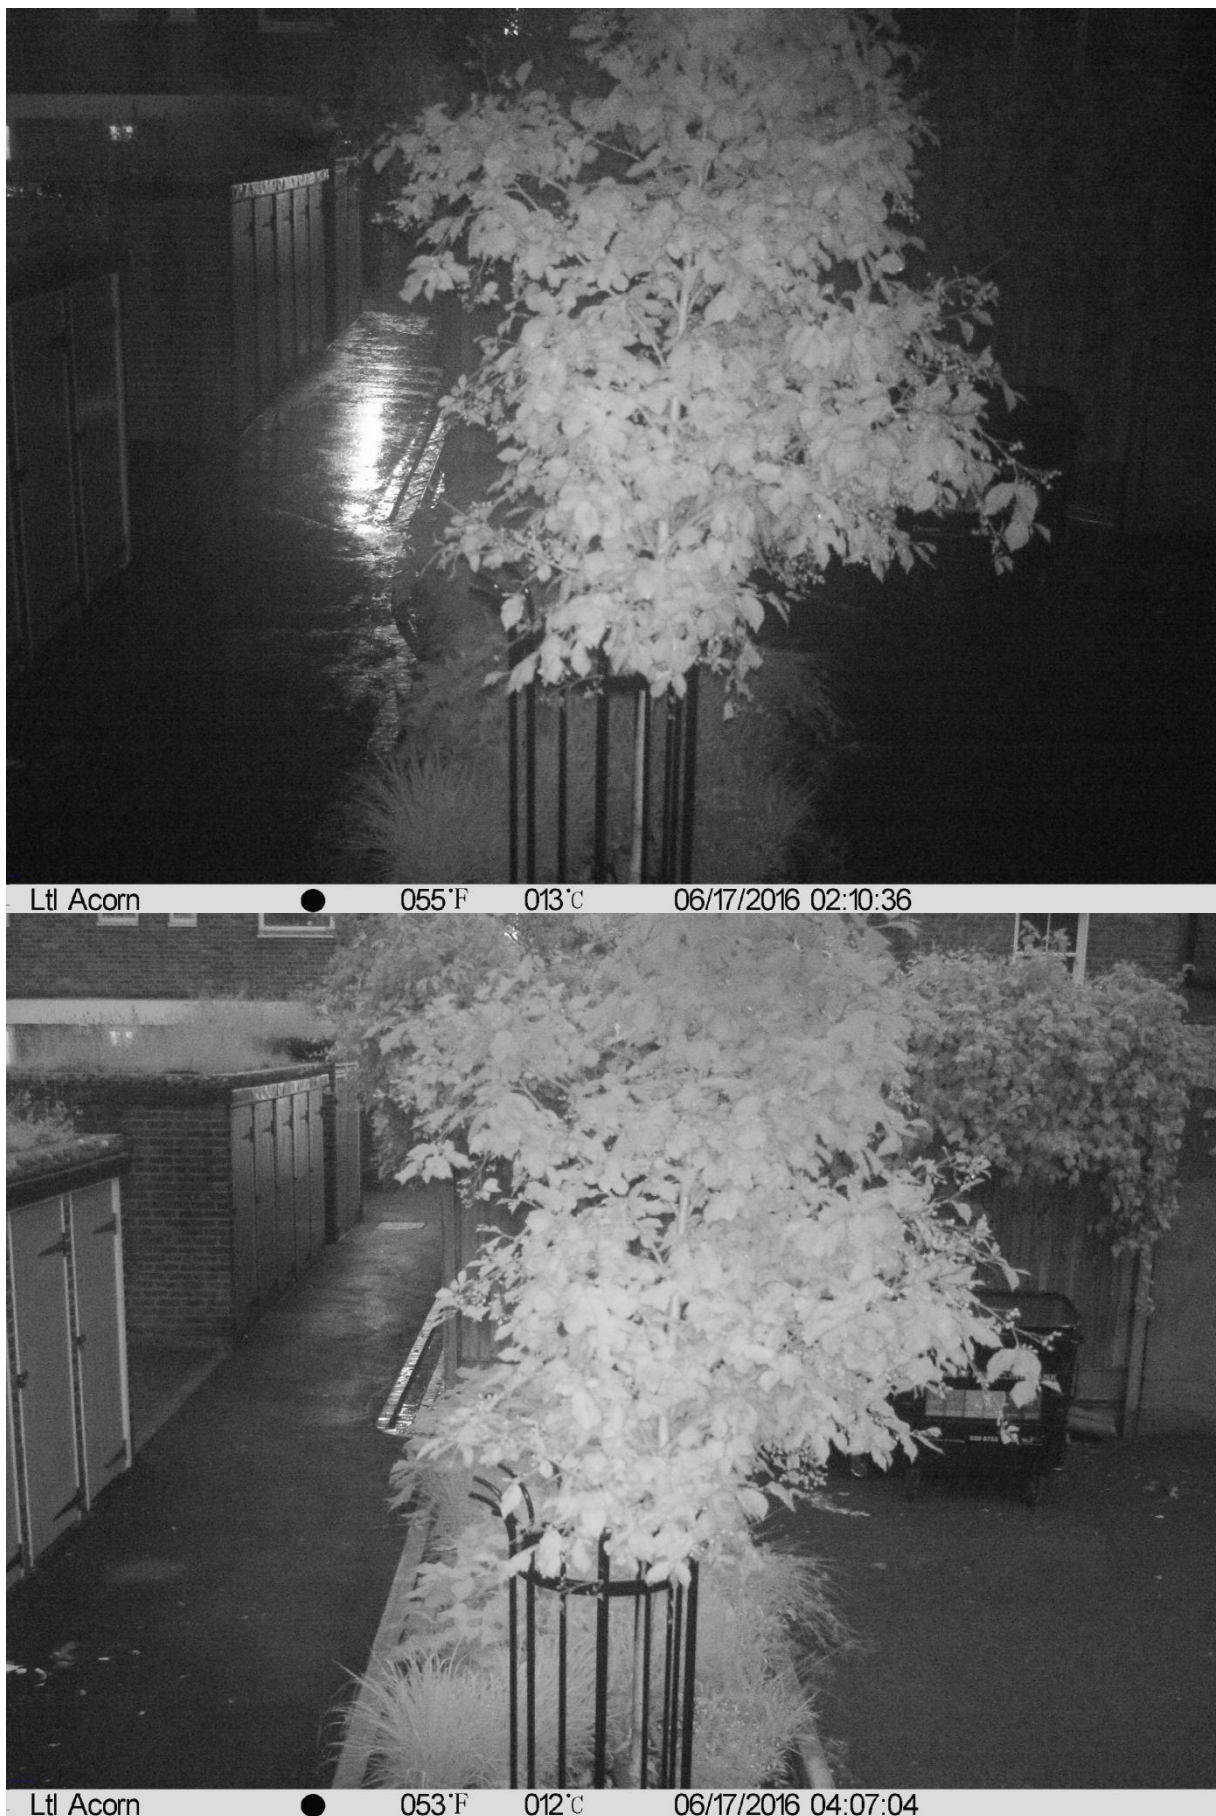
**Figure 17. Time-lapse camera images from Richard Knight House rain garden (FPC5).** Images show i) rain garden during the period of rain building up to the highest rain intensity and ii) following the period of highest intensity.

Despite this intense and substantial nature of the rainfall over a short period, the time-lapse camera images revealed no evidence of excessive filling of the Richard Knight House rain garden (Figure 17).

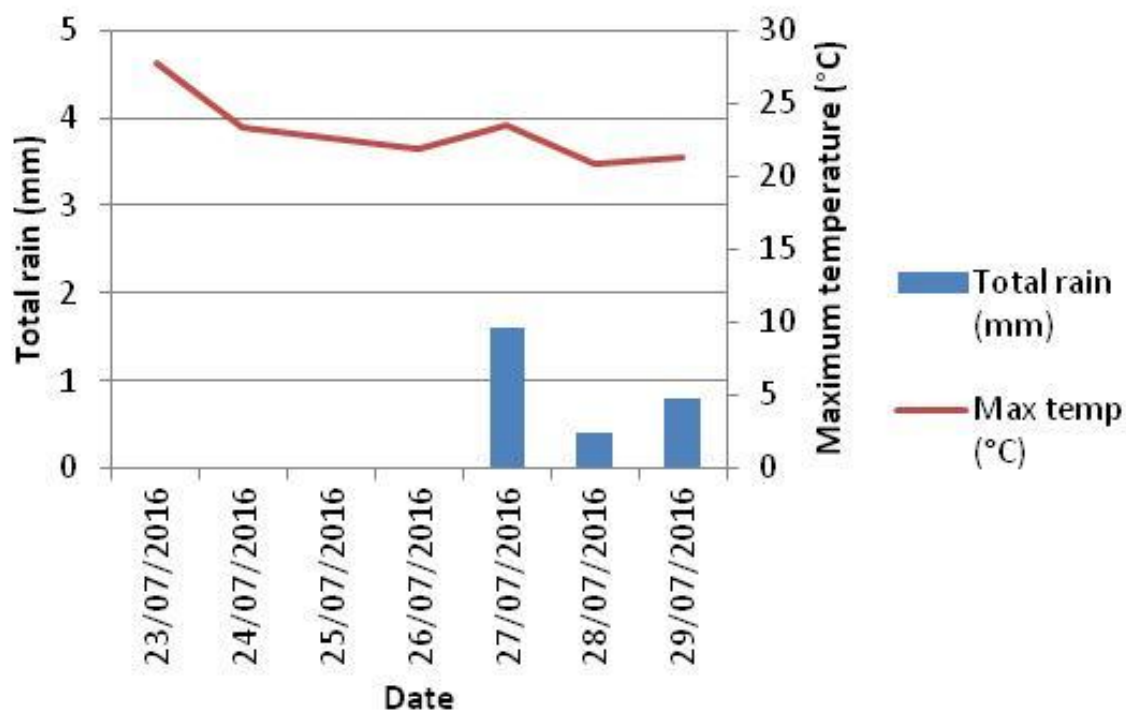
**Figure 31. Weather conditions at Queen Caroline Estate, London Borough of Hammersmith and Fulham, preceding the storm event simulation at Beatrice House swale.**

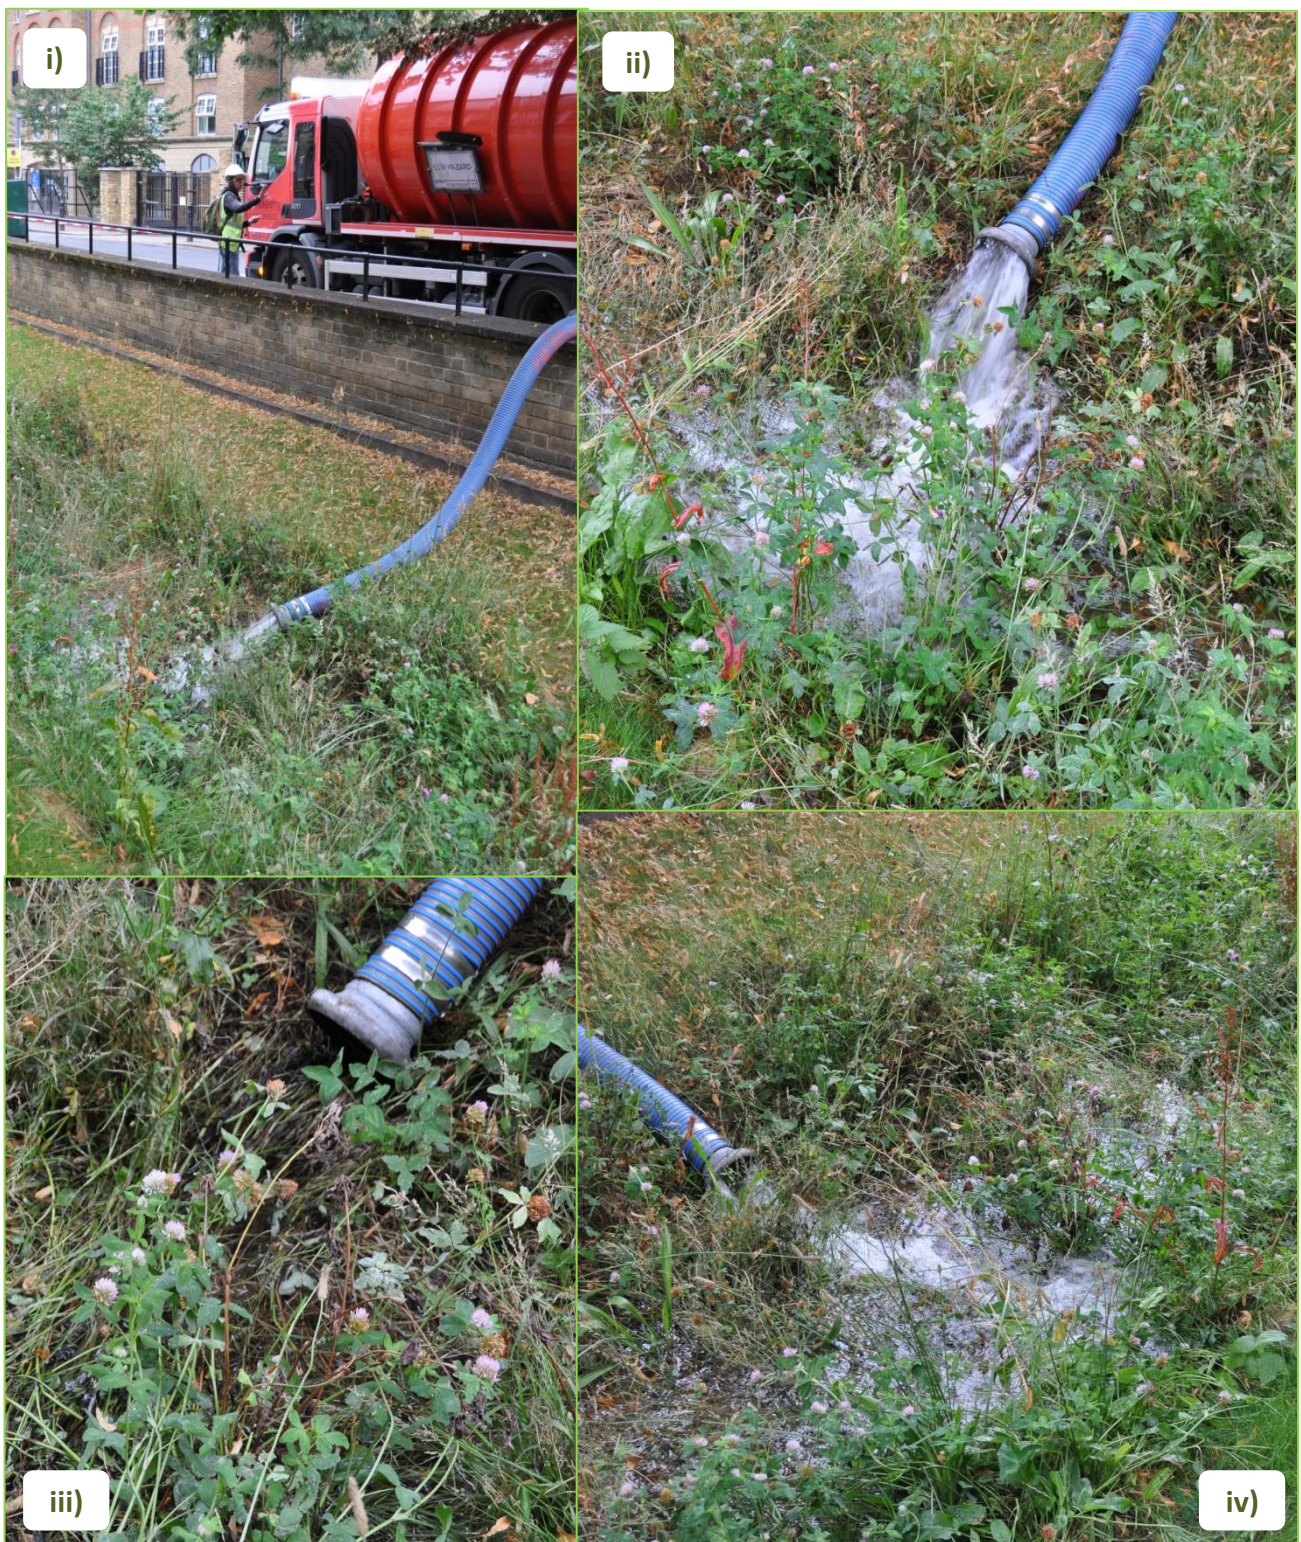
**Figure 32. Images from the storm simulation event at Beatrice House swale, Queen Caroline Estate, 29th July 2016.** Images show i) water release from tanker being timed to release 1000 Litres every six minutes; ii) 1000 Litres entering the centre of the swale; iii) condition of the swale after the first 1000 Litres; iv) condition of the swale as it starts to fill after several 1000 Litres releases.

Photographs documenting the storm simulation process are presented in Figures 32 to 34.

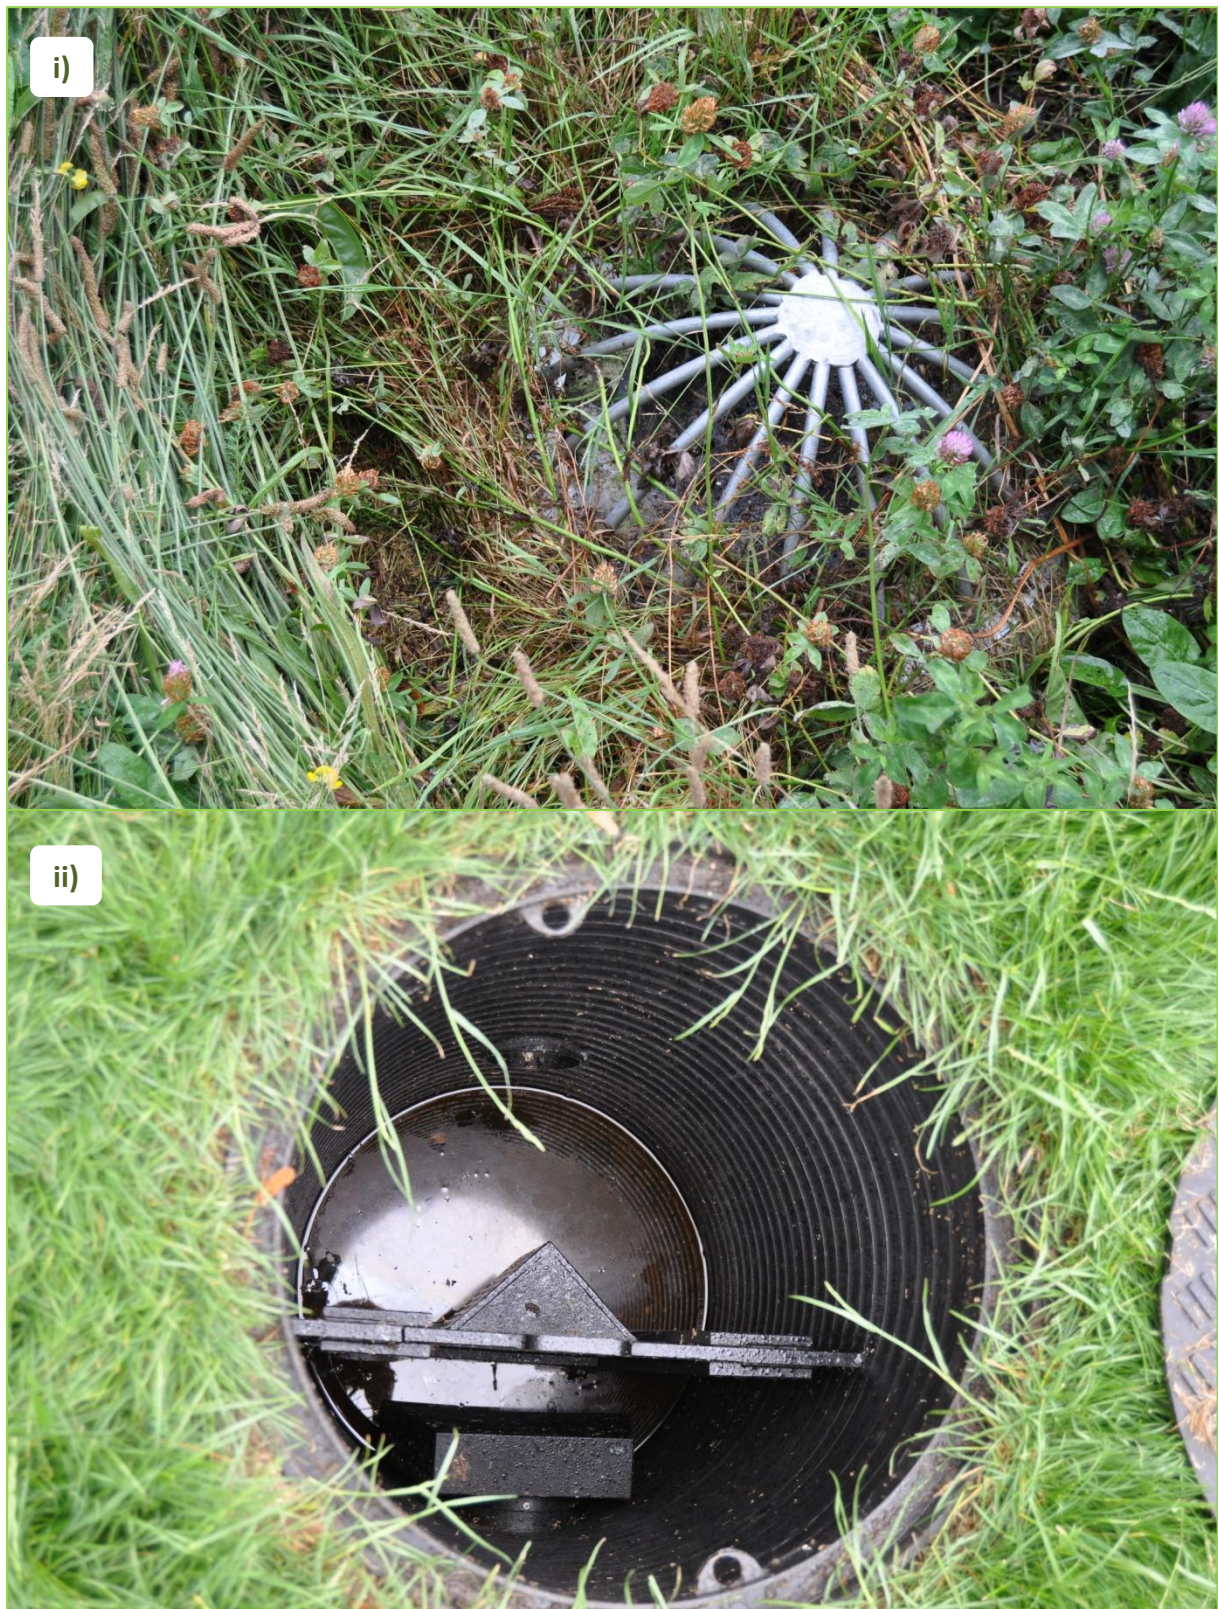
**Figure 33. Images from the storm simulation event at Beatrice House swale, Queen Caroline Estate, 29th July 2016.** Images show that no water was released to the i) swale overflow or ii) the control flow chamber, after the 10,000 Litres of water were pumped into the swale to simulate a 1 in 100 year storm event.

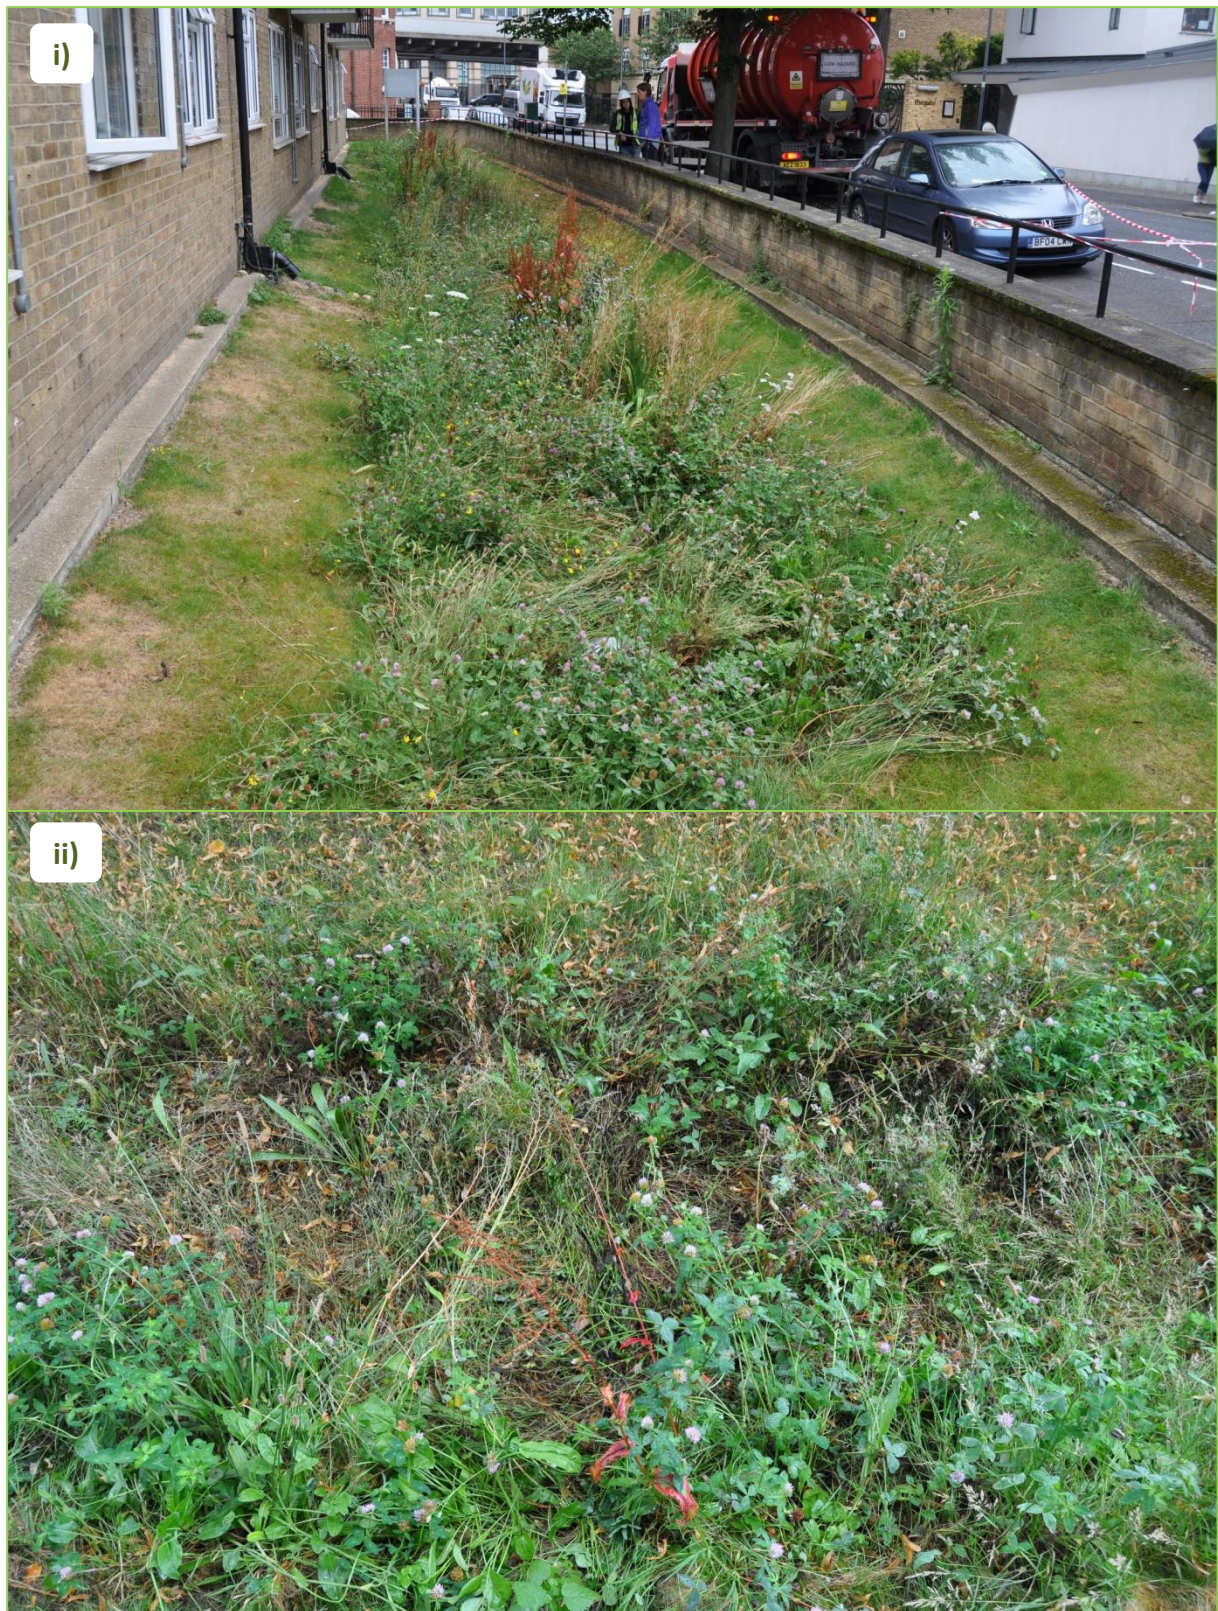
**Figure 34. Images from the storm simulation event at Beatrice House swale, Queen Caroline Estate, 29th July 2016. Images show i) the Beatrice House swale immediately after the last of the 10,000 Litres of water was released and ii) the centre of the swale where the water was pumped in 15 minutes after the last of the water was released.**

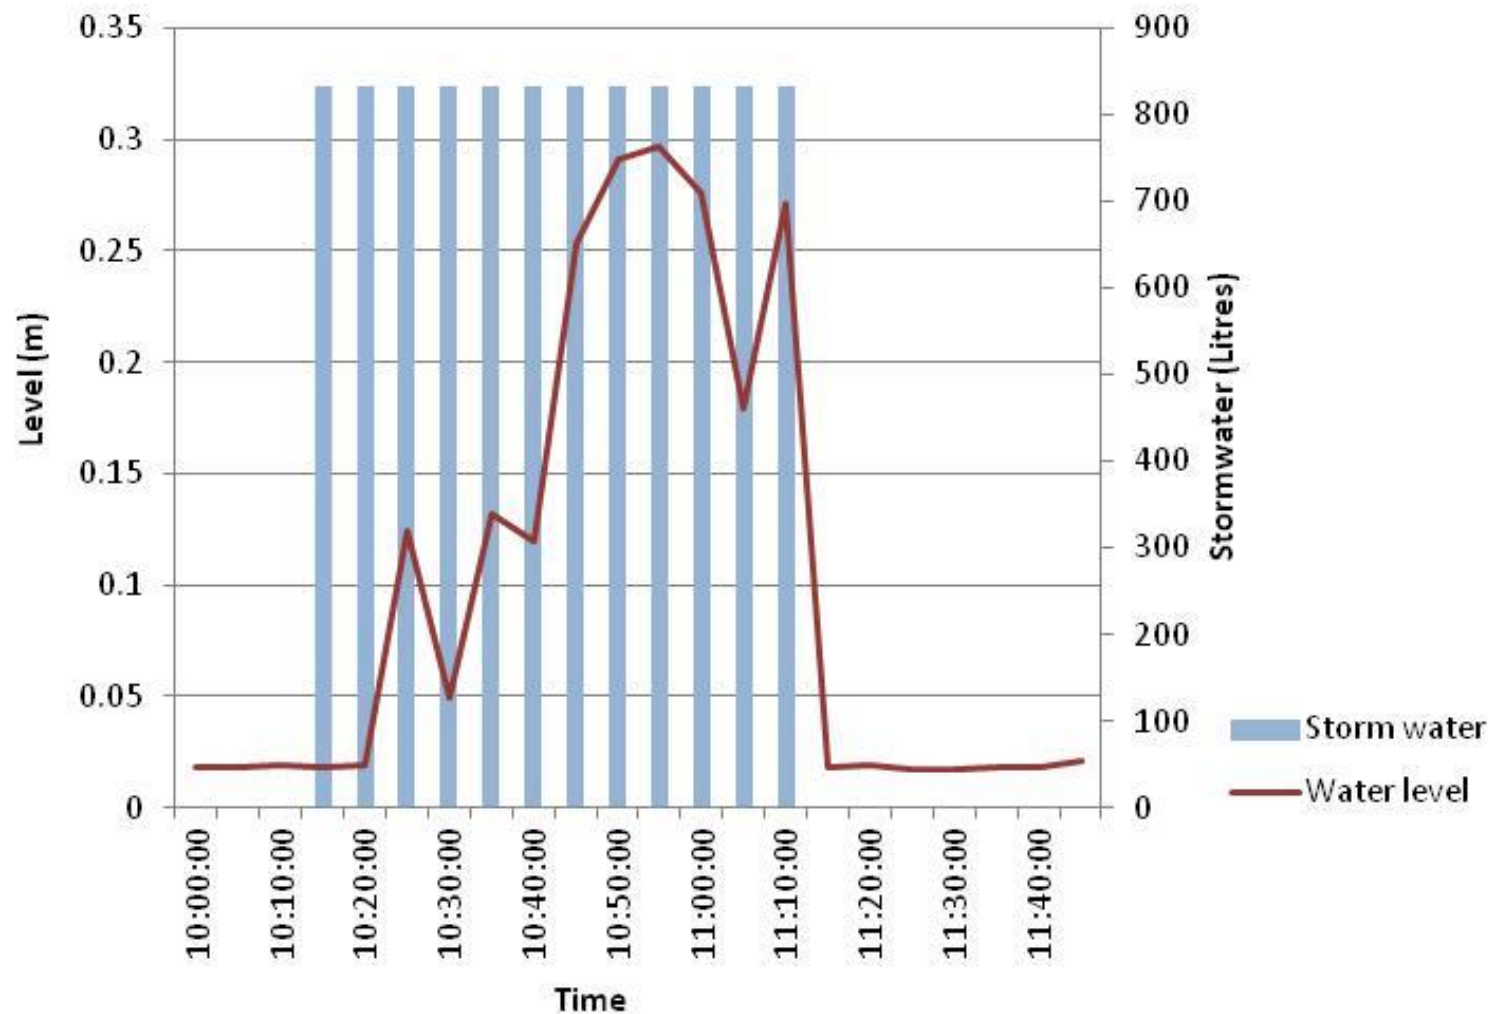
**Figure 35. Pressure sensor data from 1 in 100 year storm simulation event at Beatrice House swale, Queen Caroline Estate, London Borough of Hammersmith and Fulham.** Blue bars represent the times when stormwater was pumped into the swale, the red line represents the readings of a pressure sensor buried beneath the swale to monitor pooling water.

In addition to retaining all of the 10,000 Litres of the storm simulation, it is also important to assess how long the water sat in the swale after the event and thus how long until the swale was empty again and the recharge volume available for another storm event. It has been suggested that London soils may be inappropriate for infiltration SuDS components as London soils are generally designated as being heavy impermeable clay and thus do not allow infiltration (Alvez et al 2014). Monitoring how long it takes for any standing water to disappear from the swale after the testing provided a good assessment of infiltration times during the event (although it is not possible to establish whether this was due to basal infiltration or lateral infiltration). Visual assessment of the swale following the study indicated that no standing water was visible within the swale 15 minutes after the storm event. This visual evidence was supported by data obtained from the pressure sensor buried at the base of Beatrice House swale (Figure 35).

Following the initiation of the storm event, the levellogger recorded no additional pressure above the baseline level. This may have been indicative of a delay between the infilling of the swale and the water infiltrating to the levellogger, or may have indicated that all of the initial storm simulation water infiltrated very quickly before saturation resulted in pooling. By the time that 2000 L of water had been pumped into the swale the water level had increased indicating that pooling/soil saturation was occurring. Following the cessation of the storm simulation (i.e. after all 10,000L had been pumped into the swale), the levellogger indicated that pooling disappeared very rapidly - within 10 minutes of the end of pumping the pressure readings had returned to the pre-testing baseline level. This data supported observations made on site and indicated that infiltration rates were fast. This provided evidence that recharge volumes would be available very quickly following a 1 in 100 year storm event during dry summer conditions. It would be interesting to repeat this test again in winter when the groundwater table would be expected to be higher and the soil more saturated to assess any effect of this on storage and recharge durations.
